Report No.: THSH201	23028	3661EN Job No.:28661	Date: January 06, 2021
Applicant	:	Gemcreate Electronics Technology (Shanghai) CO., L	TD
		Floor 3-1, Building 1, Jiaotong University Science Park	r, NO.1599 Fengpu Avenue,
		Feng Xian District, Shanghai 201499, P.R. China	
Sample Description	:	Transmitter instrument housing	
Sample Material	:	316 stainless steel	
Date Received	:	December 30, 2020	
Test Period	:	December 30, 2020January 06, 2021	
Test Requested	:	IP67	
Test Method	:	IEC 60529:1989+A1:1999+A2:2013	
Conclusion	:	Pass

1. Test Item: IP6X Dust proof

2. Test Item: IPX7 Water proof

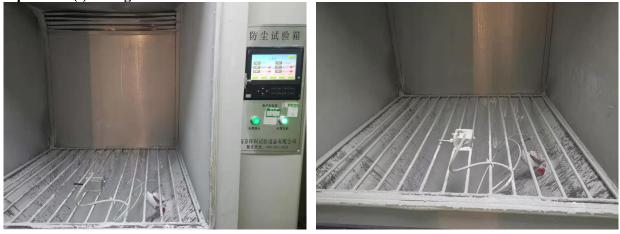
Sample Photo(s) during the test:

Test Method:	IEC 60529:1989+A1:1999+A2:2013 Degrees of protection provided by enclosures (IP 6X)		
Test setup:	Dust-proof chamber, Model No. SC-010		
Environment:	24°C, 53%RH, 103kPa		
Test Conditions:	: 1) Maximum depression : 2kPa.		
	2) Test period: 8 hours		
	3) Extraction rate: 40 volumes per hour

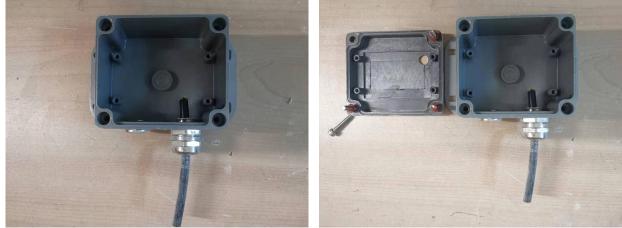
Sample Photo(s) after the test:

Sample Name	Test Results	
Transmitter instrument housing	No dust observed inside the test sample

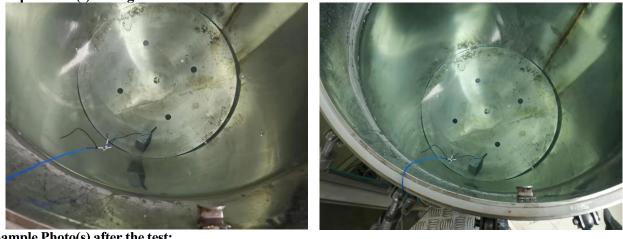
Sample Photo(s) during the test:

Test Method:	IEC 60529:1989+A1:1999+A2:2013 Degrees of protection provided by enclosures (IP X7)	
Test setup:	Water proof test chamber, Model No. IPX1-8	
Environment:	26°C, 53%RH, 103.5kPa	
Test Conditions:	1) Depth of water: 1m	
	2) Test period: 30 min

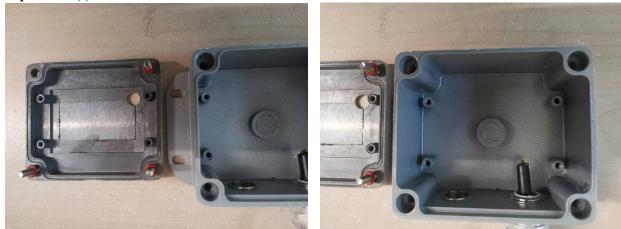
Sample Photo(s) after the test:

Sample Name	Test Results	
Transmitter instrument housing	No Water entered the cavity of sample after this test
